# Manhole Inspection Summary

Manhole # S41UU\_002MH

Insp Date: **2/15/07 2:08 PM**

**Location** Address: **1419 HOMESTEAD AVE**

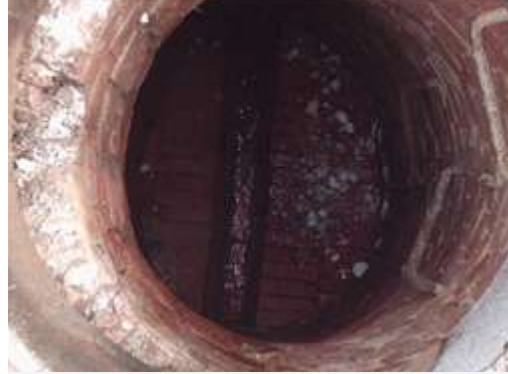
Top View

Corroded steps.

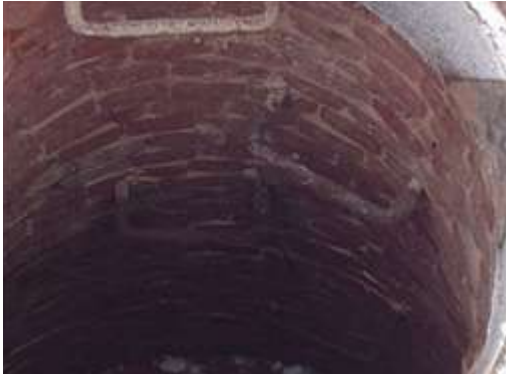
Defect

☒ **Leaks**

Frame leaks. Corbel and Barrel infiltration.

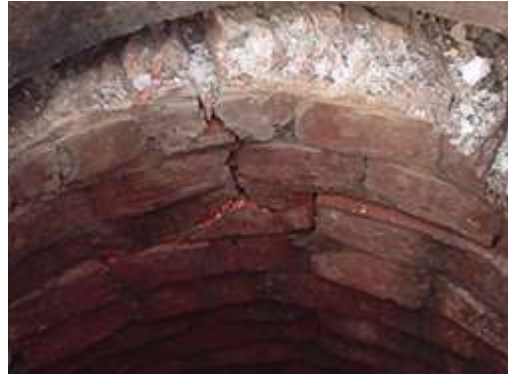
Defect

**Frame** Offset: **4** (in.)

Condition: ☐ Sound ☒ **Cracked** ☐ Root Intrusion ☐ Loose Brick ☒ **Deteriorated**

Frame offset. Adjustment and Corbel deterioration, cracks and infiltration.

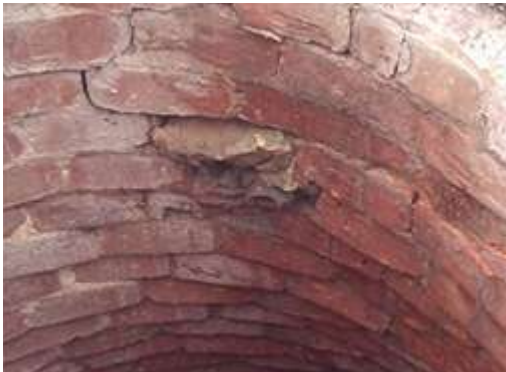
Defect

Condition: ☐ Sound ☒ **Cracked** ☐ Root Intrusion ☐ Loose Brick ☒ **Deteriorated**

Adjustment and Corbel deterioration and infiltration.

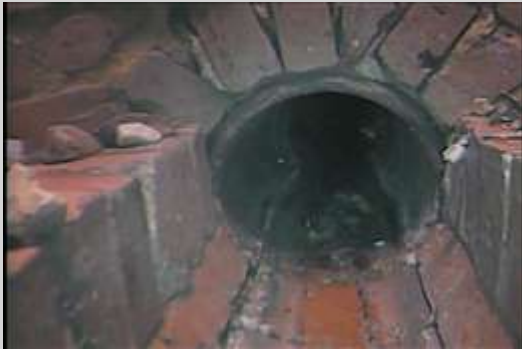
### 8 in. Circular Gravity Sewer Pipe Out @ 12 O'Clock

Barrel deterioration and infiltration. Channel and Bench deterioration.

Deposits: ☐ None ☒ **Mud** ☐ Sludge ☒ **Debris** ☐ Grease

Infiltration: **Evidence** Pipe Seal Cond: **Cracked**

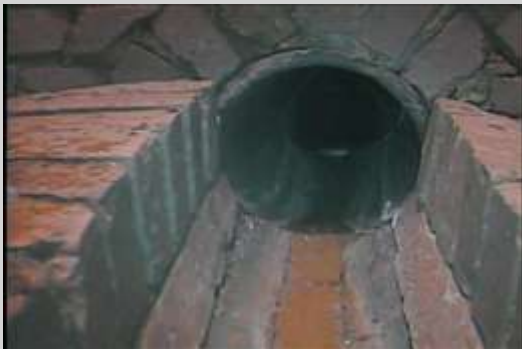
### 8 in. Circular Gravity Sewer Pipe In @ 6 O'Clock

Barrel deterioration and infiltration. Channel deterioration.
